HOUSING DISCRIMINATION COMPLAINT

The Brixton 421 S Broadway Baltimore, MD 21231

Complainant Equal Rights Center has investigated violations of the Fair Housing Act's accessibility requirements at Respondents' property, The Brixton, located in Baltimore, MD.

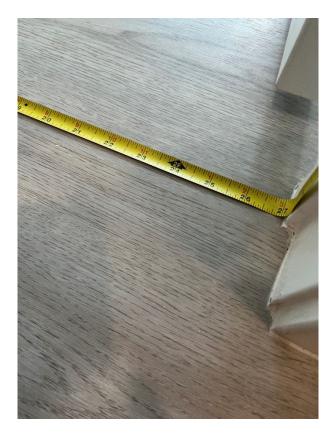
Through its testing at The Brixton, Complainant identified clear openings at bedroom doors measuring between 27 inches and approximately 29 inches wide, short of the nominal 32" minimum width required by the FHA. Specifically, Complainant observed a clear opening measuring approximately 27 inches in width at the bedroom door to Unit 409 (Figure 3), and approximately 29 inches at the bedroom door to Unit 302 (Figure 4).

Figure 3: Unit 409 bedroom door measuring approximately 27 inches.

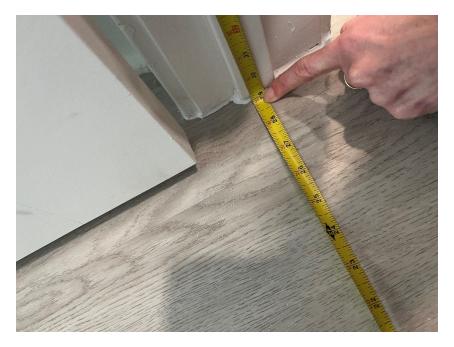
Figure 4: Unit 302 bedroom door measuring approximately 29 inches.

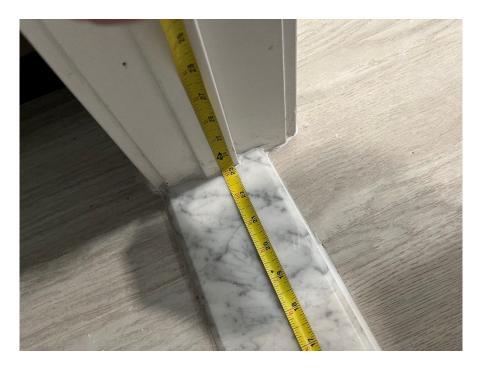
Complainant also observed bathroom doors measuring less than 32 inches wide in the units it tested. Specifically, Complainant observed a clear opening measuring approximately 23 inches in width at the bathroom doors to Unit 302 (Figure 5) and Unit 409 (Figure 6), and 27 inches wide in Unit 411 (Figure 7).

Figure 5: Unit 302 bathroom door measuring approximately 23 inches.

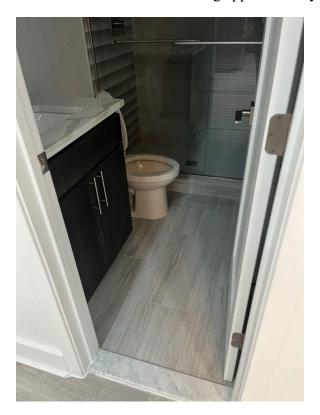
Figure 6: Unit 409 bathroom door measuring approximately 23 inches.

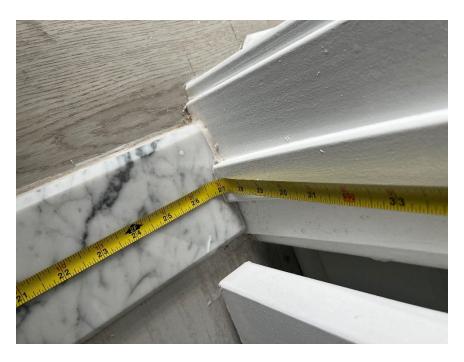
Figure 7: Unit 411 bathroom door measuring approximately 27 inches.

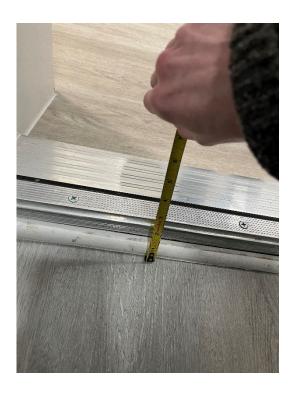
During its testing, Complainant observed noncompliance with these guidelines at both primary and secondary exterior doors and in the interiors of units. As to exterior doors, Complainant measured an unbeveled threshold of 2 inches at the primary door to Unit 411 (Figure 8), and unbeveled thresholds of approximately 1.5 inches at the primary doors to Units 302 and 409 (*See, e.g.*, Figure 9).

Figure 8: Unit 411 primary exterior door threshold measuring approximately 2 inches.

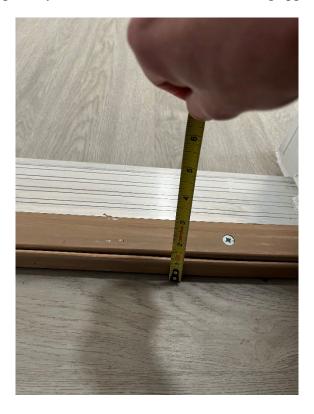
Figure 9: Unit 409 primary exterior door threshold measuring approximately 1.5 inches.

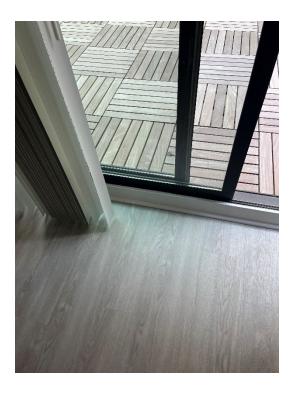
Additionally, Complainant observed unbeveled thresholds of up to several inches at secondary exterior doors exiting onto decks. Specifically, Complainant noted an unbeveled threshold exceeding one inch at the door leading to Unit 302's exterior patio made of pervious wooden material (Figure 10). And it noted an unbeveled threshold of 5 inches at the door leading to Unit 409's exterior patio composed of impervious metal material (Figure 11). Finally, it noted what appear to be unbeveled thresholds in excess of 1/4 inch in the doorways to the bathrooms of Unit 302, Unit 409, and Unit 411 (*see supra* Figures 5, 6, and 7). All of these configurations significantly exceed the threshold heights allowable under the guidelines.

Figure 10: Unit 302 secondary exterior door threshold measuring in excess of 1 inch.

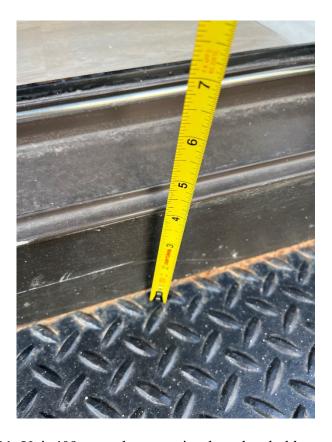
Figure 11: Unit 409 secondary exterior door threshold measuring 5 inches.

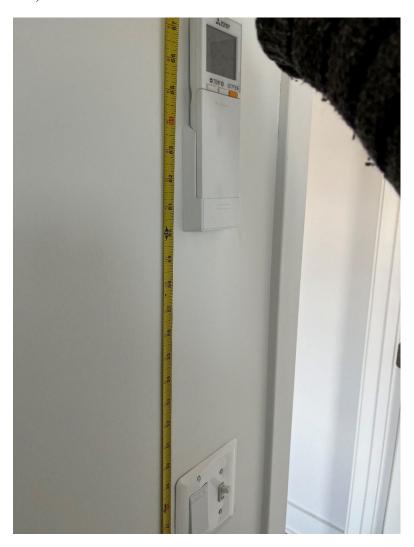
During its testing, Complainant observed temperature control devices which have been installed with the lowest operable part of the control at 60 inches, 12 inches higher than the accessibility requirement of no more than 48 inches. Inaccessibly high devices were observed in all of the units Complainant tested, including Units 302, 409, and 411 (*See, e.g.*, Figure 12).

Figure 12: Unit 411 temperature control device mounted above 60 inches.

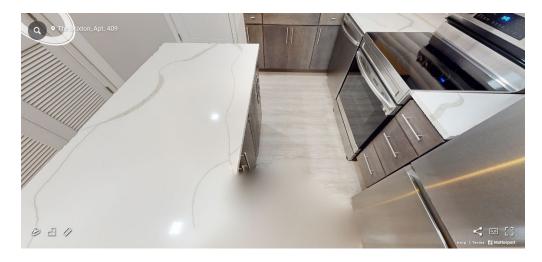
Complainant observed several violations of these rules through its testing. These include an immovable kitchen island that affords approximately 36 inches of clearance between the counters and opposing appliances in Unit 409 (Figures 13 and 14); an oven that opens approximately two inches and directly into opposing appliances in Unit 302 (Figure 15); and a range-equipped unit with a U-shaped kitchen that allows less than 60-inch turning diameter in Unit 302 (Figure 15).

Figure 13: Clearance between kitchen counters and appliances in Unit 409.

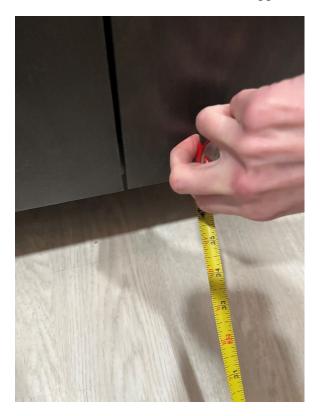
Figure 14: Unit 409 measuring approximately 36 inches of clearance between kitchen counters and appliances.

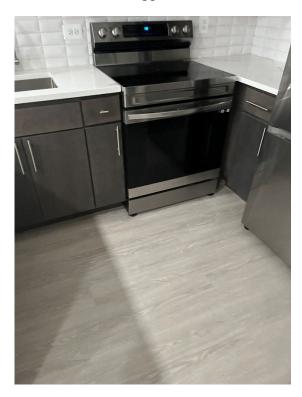
Figure 15: Unit 302 kitchen featuring oven opening approximately two inches and onto opposing appliances, and less than 60 inches turning diameter.

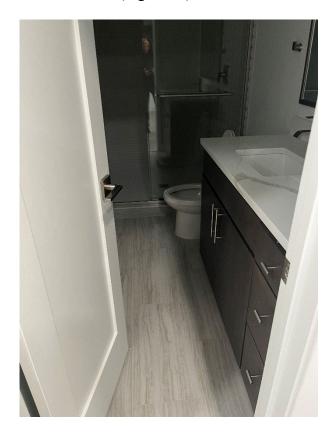
During its testing, Complainant noted that all of the units it viewed appeared to feature bathrooms with less than the 30" x 48" of clear floor space called for by the Design Manual. These include Units 302, 409, and 411 (Figures 16, 17, and 18). Additionally, Complainant observed units with toilet centerline distances of greater than the 18-inch maximum allowed under the safe harbors. Specifically, Complainant measured a toilet centerline of 19.5 inches in Unit 302 (Figure 19).

Figure 16: Unit 302 bathroom featuring less than 30" x 48" of clear floor space.

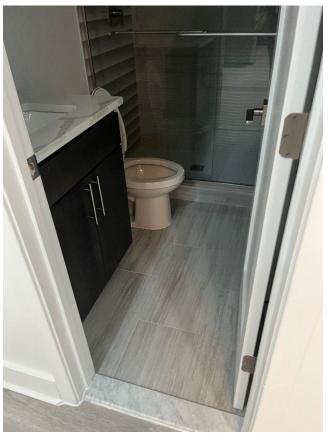
Figure 17: Unit 409 bathroom featuring less than 30" x 48" of clear floor space.

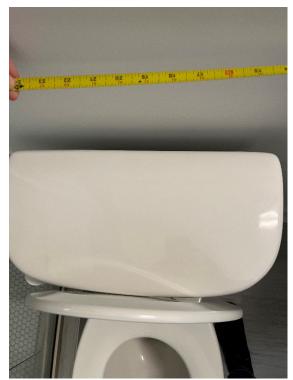
Figure 19: Unit 302 toilet centerline of approximately 19.5 inches.
